## Using Infrared Thermography as an Added Diagnostic Tool in Building Inspections

Roy Chan  
Consumers Choice Property Consultants Inc.

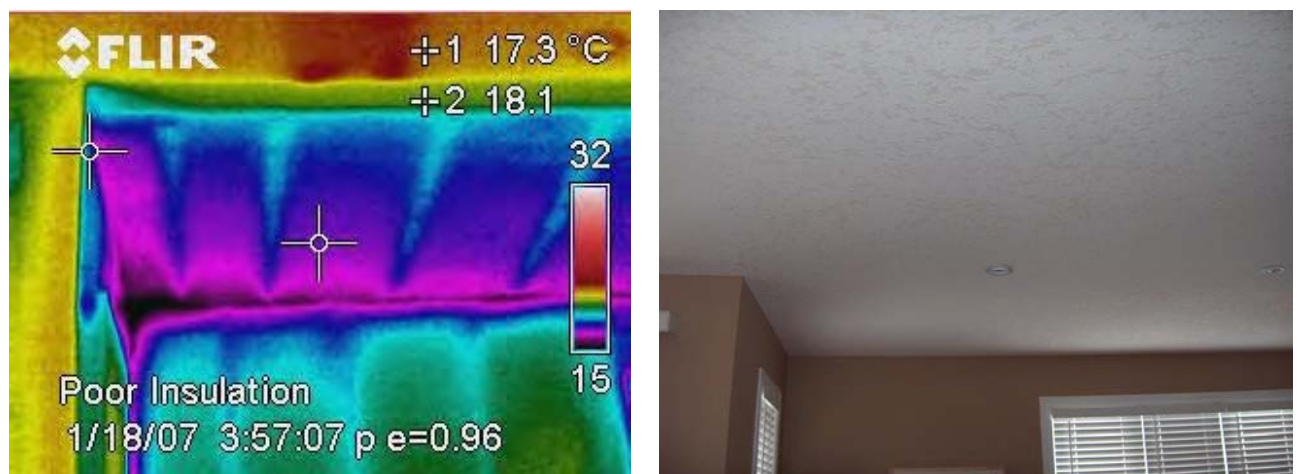
Figure 1 is an IR image of missing insulation on the ceiling below an open balcony in a brand new house. The owner was perplexed by why it was so drafty sitting on the couch by the exterior wall until we showed up with the IR camera and demonstrated the insufficient insulation in the ceiling space which created the air leakage. In fact, this design was the owner's idea in the first place – back to the drawing board!

Figure 1. Thermogram and photo pair showing missing insulation on the ceiling below an open balcony.

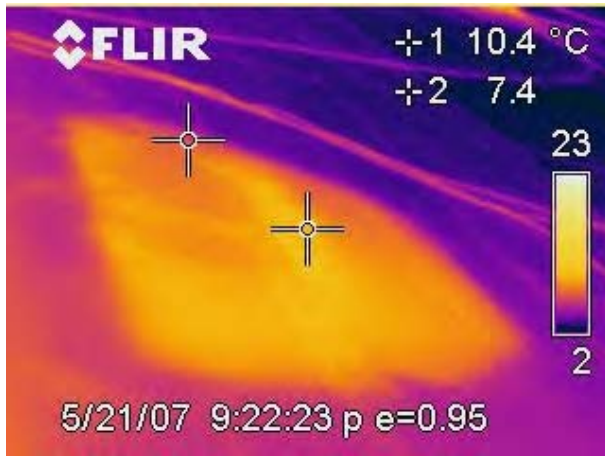
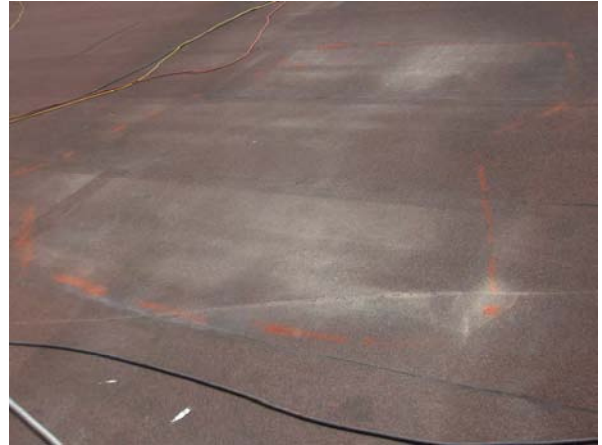
Figure 2 shows the IR image of the wet insulation under the single-ply flat roof which has premature leaks. The owner has a hard time finding the leaks until we showed up with our IR camera and found all the hot spots on the roof. Now, all they have to do is fix the marked areas.

Figure 2. Thermogram and photo pair showing moisture embedded insulation on a single ply flat roof.

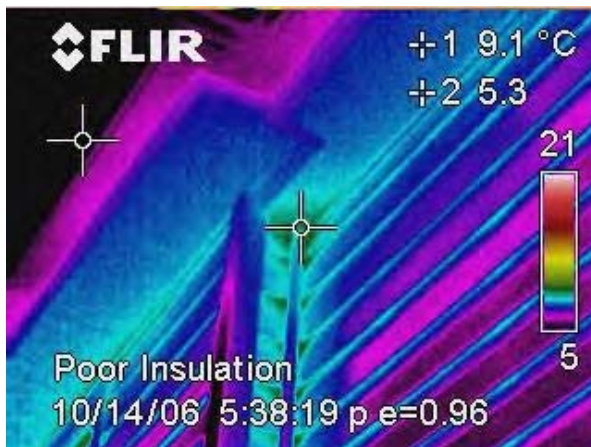
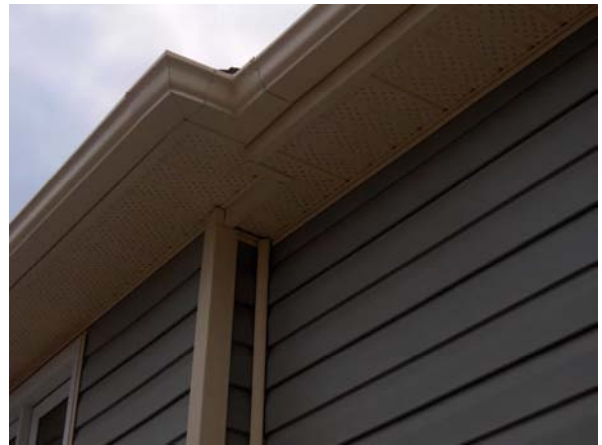
Figure 3 shows the IR image of the warm air coming out of the corner of the house during an inspection. IR thermography can be applied to perform an energy audit.

Figure 3. Thermogram and photo pair showing air leakage in a house inspection.

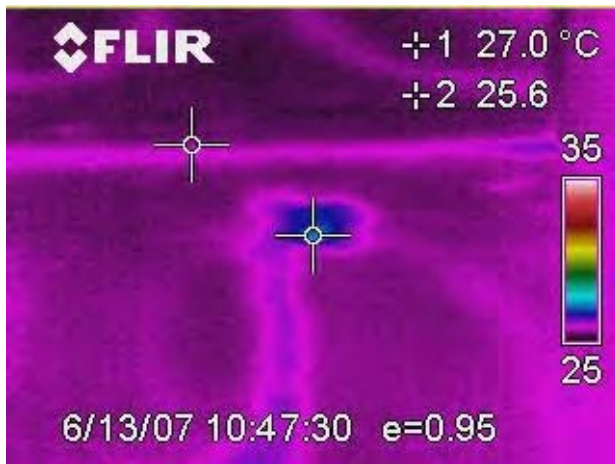
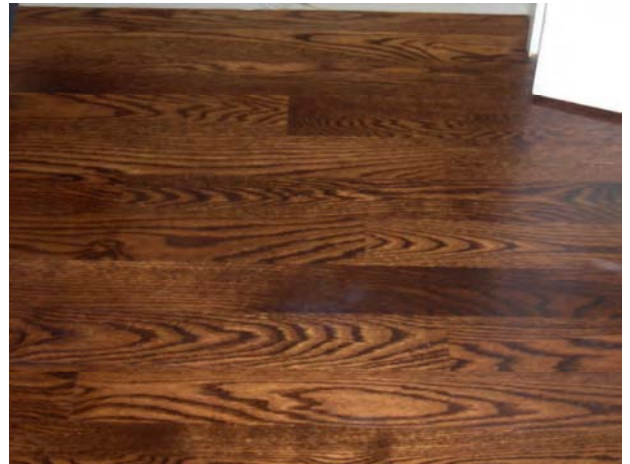
Figure 4 shows the IR image of the water leak in a radiant floor heating pipe. Our service saves the owner from taking out all the flooring in order to find the leak. We can apply the IR camera and pinpoint the location to verify it.

Figure 4. Thermogram and photo pair showing broken pipe in the radiant floor heating system.

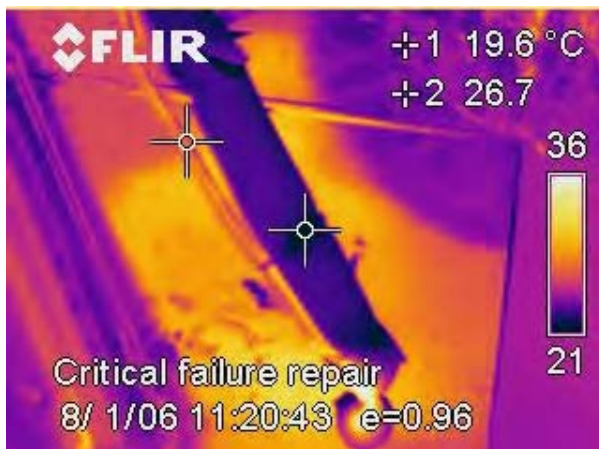
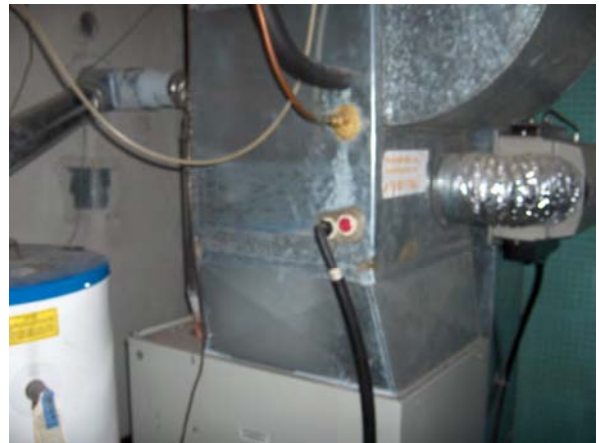
Figure 5 shows the IR image of the non-performing brand new A/C system during an inspection. The owner has been finding puddles of water on tile and basement floors, and the relative humidity shot up after a new A/C system was installed. After a series of test by elimination, we finally determined that the problem was the non-performing A/C unit. The contractor has to return to fix it.

Figure 5. Thermogram and photo pair showing inefficient new A/C system.

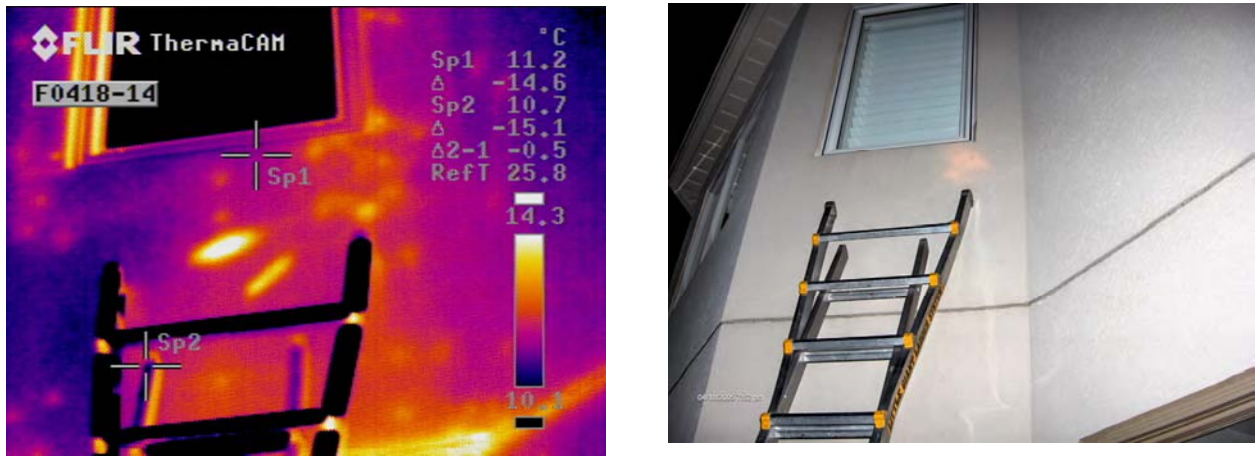
Figure 6 shows the IR image of moisture inside the stucco wall. The house was only six year old and from day one there were bubbles and patches. The builder has to return every year to patch the bubbles and within 6 years there were 50 or more patches. Finally, the owner decided to hire us to scan on all the EIFS walls and take up with the builder.

Figure 6. Thermogram and photo pair showing moisture inside the EIFS cladding.

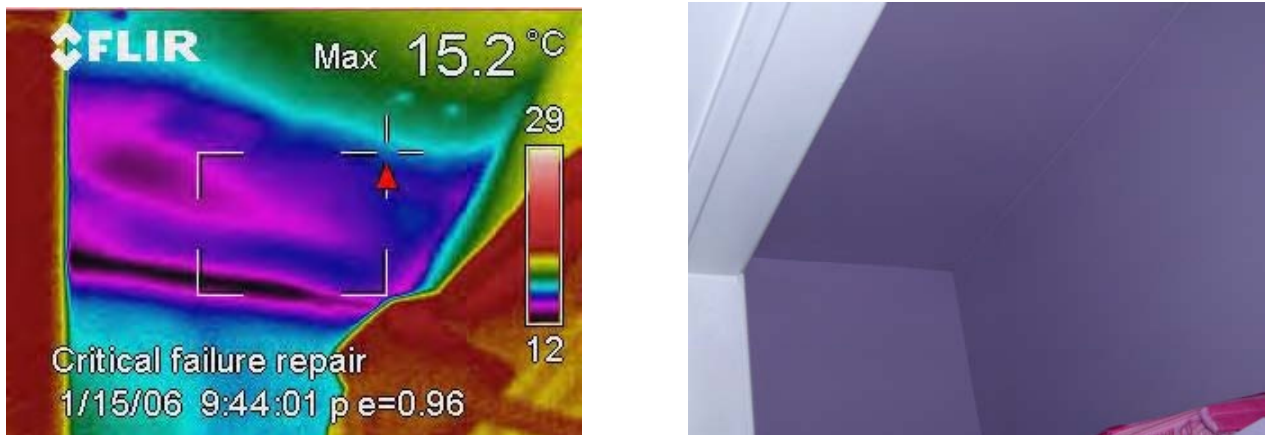
Figure 7 shows the IR image of the missing insulation inside the ceiling of a bedroom. The house has just been restored by a contractor after the house experienced a fire. Most of the second floor has rebuilt. After the restoration, my client moved back into the house and found the bedrooms to be very drafty and called us to investigate. We scanned the entire second floor and found almost every room experienced poor insulation and finally the insurance company agreed to allow my client to re-do the work again after taking out the previous inferior work.

Figure 7. Thermogram and photo pair showing missing insulation in the ceiling.
